The most efficient protection for RJ45 Patch cords

Technical Data Sheet

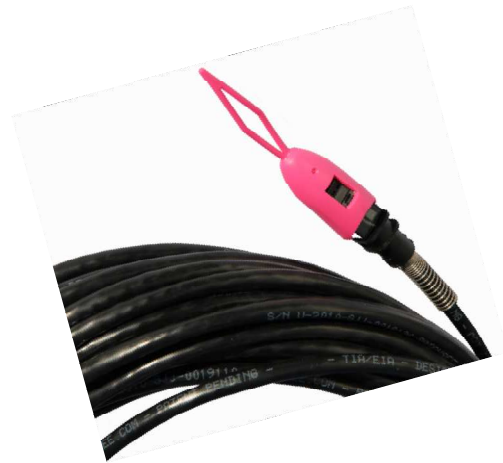
- The plug is fully protected from the start, up to the final connection.
- The plastic body which fully covers the plug is fitted with an eye to pull the network cable through a false floor, or through an electrical flexible conduit without any risk of damaging to the plug. The protection is left on until final connection.
